**HAZARDOUS MINE OPENING
MAINTENANCE PROJECT
DSL/AMRB PROJECT NO. 93-M08**

HAZARDOUS MINE OPENING MAINTENANCE PROJECT
DSL/AMRB PROJECT NO. 93-M08

July 1994

RE: Hazardous Mine Opening Maintenance Project - Final Report

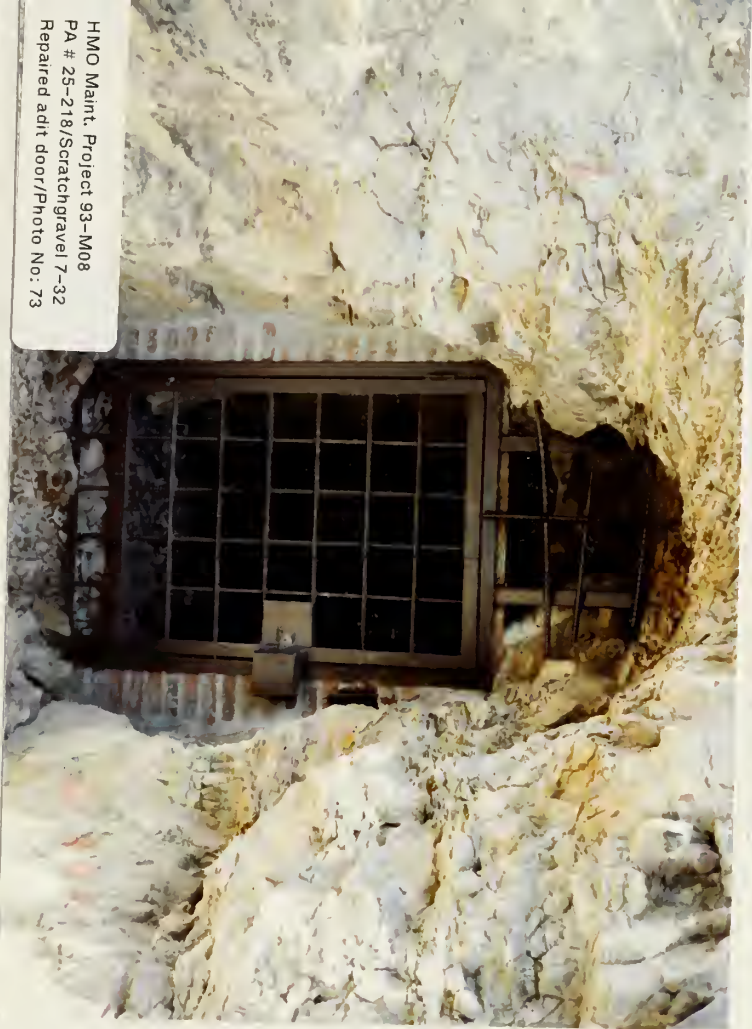
HMO Maint. Project 93-M08
PA # 25-218/Scratchgravel 7-32
Repaired adit door/Photo No: 73

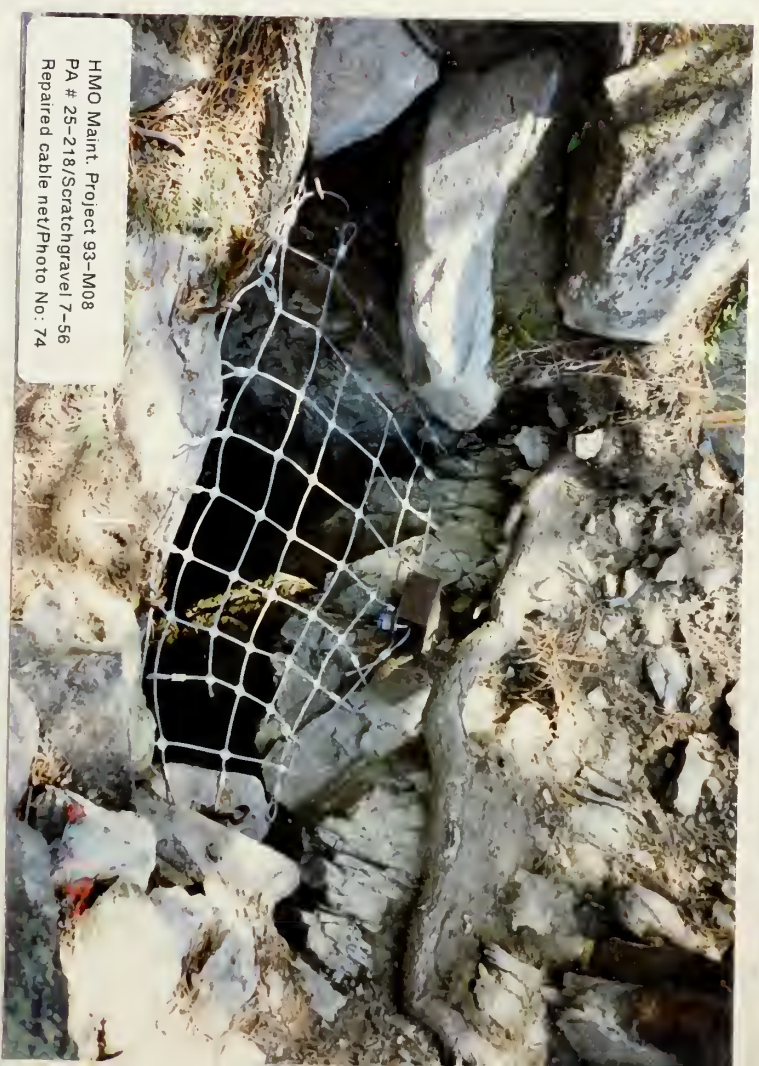
HMO Maint. Project 93-M08
PA # 25-218/Scratchgravel 7-56
Repaired cable net/Photo No: 74
